Daily Update May 18

Repair Work

Devil's Slide (post mile 39.14)

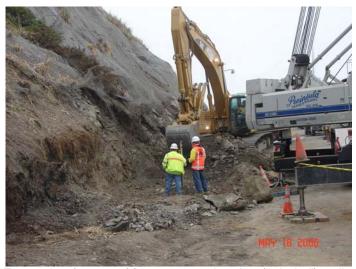
• Excavation work continued for the concrete "whaler" walls.

Excavating for one of four concrete bracing ("whaler") walls.

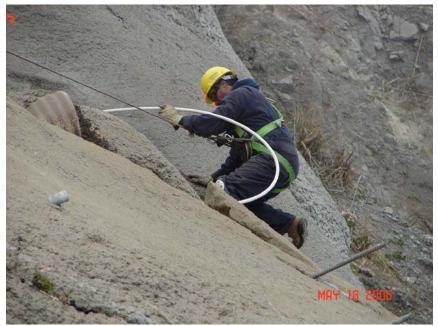
Cracks in the existing shotcrete face were sealed by injecting grout.
Shotcrete was applied below the road after the 1995 slide to prevent additional cliff erosion.

Injecting grout to seal cracks in the existing layer of shotcrete.
